**NEWSLETTER**  
**FEBRUARY 2010, ISSUE 6**

## Repair of Brill Windmill completed

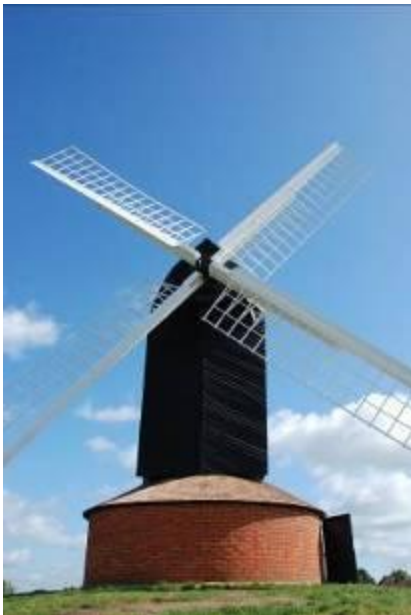
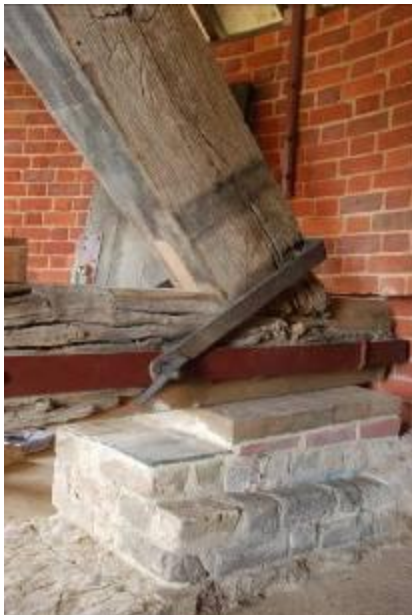
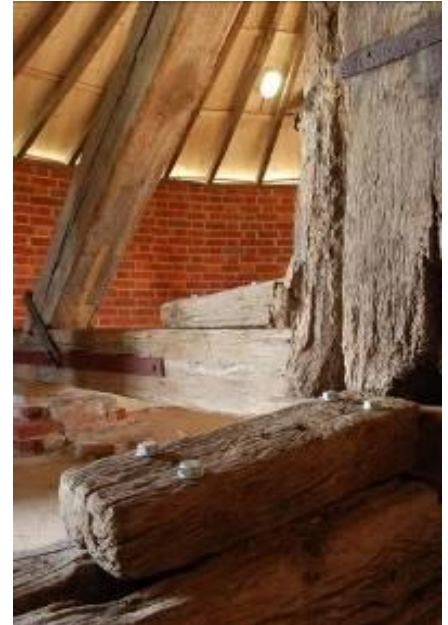
The works were informed by detailed historical research carried out by a specialist mill consultant. This allowed many elements, some unique to the windmill at Brill, to be reinstated, such as: the reconstruction of the roundhouse to an authentic design; the replacement of the missing tail ladder and the reinstatement of the rear doors to the buck; the repair of the original tailpole and the replacement of the missing cart wheel, and the renewal of the sails.

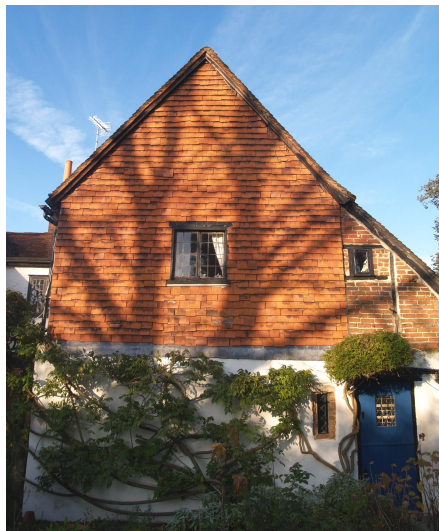
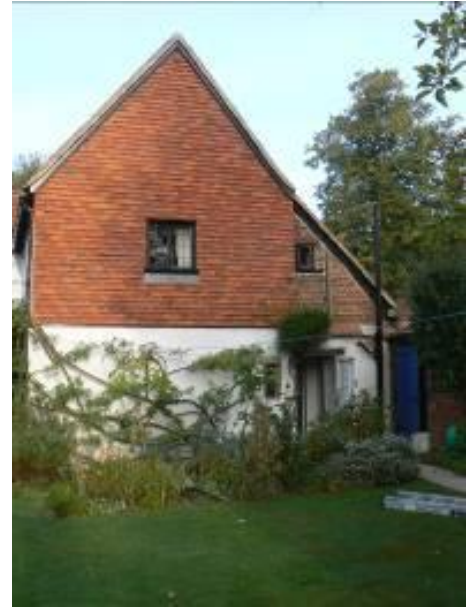
## Improving access - The Old Fire Station Gallery, Henley-on-Thames

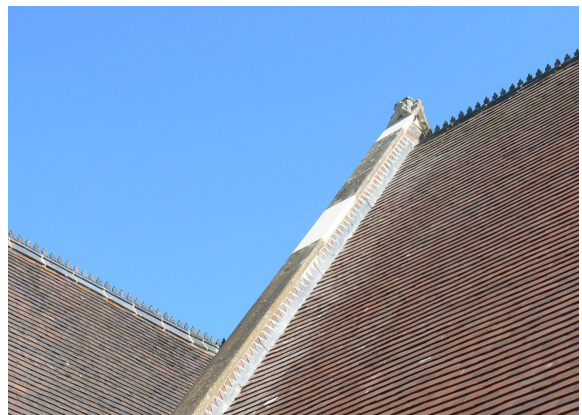
**A century of weathering**  
**Church of the Sacred Heart of Jesus, Reading**

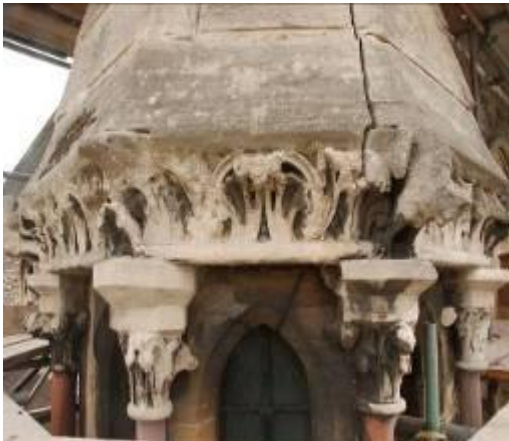
*The north west stair turret; structural movement and severe weathering of stonework is the result of poor weather detailing to the stone roof of the stair turret. The deterioration of the supporting capitals has contributed to the movement of the roof.*

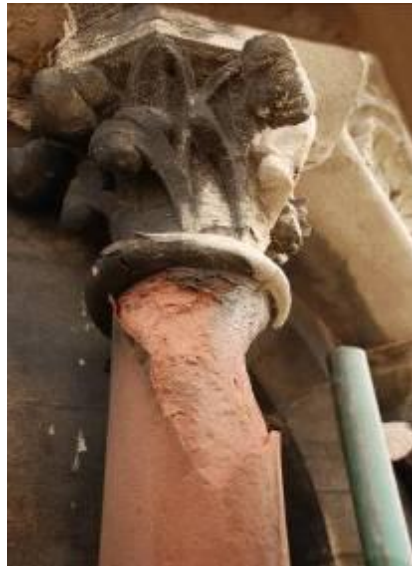
*An example of the severe deterioration of the stonework at the church.*

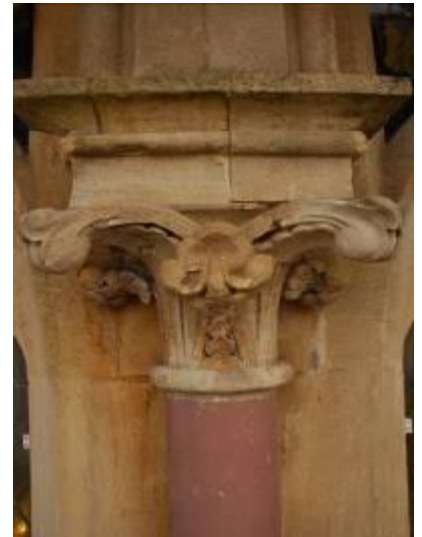
*Works in progress: the repair and consolidation of a capital to the west gable of the nave.*

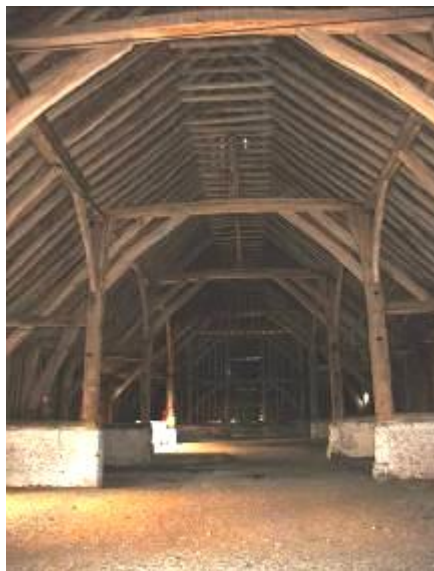
*The barn at Croxley Hall Farm*

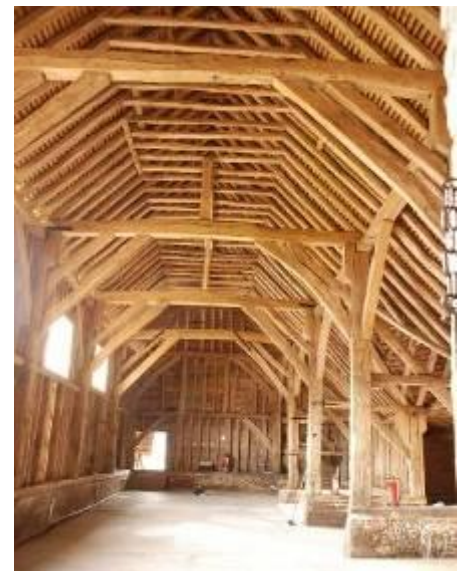
*The repaired barn at Kingsbury Manor*

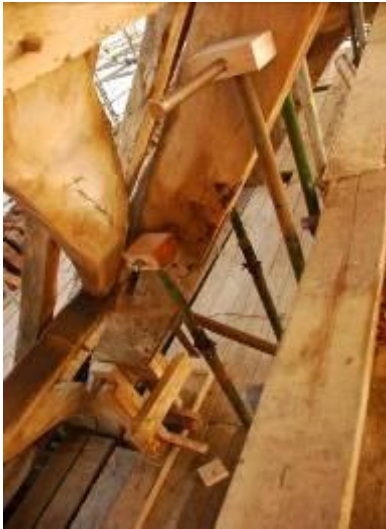
*One of the cruck blades in the process of being carefully realigned into an improved position.*

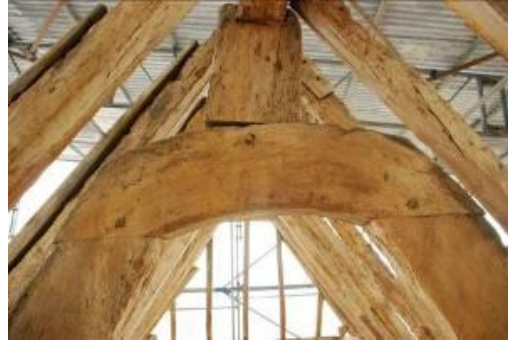
*Detail of the apex to one of the cruck cross frames, showing oak timbers over 600 years old in excellent condition*

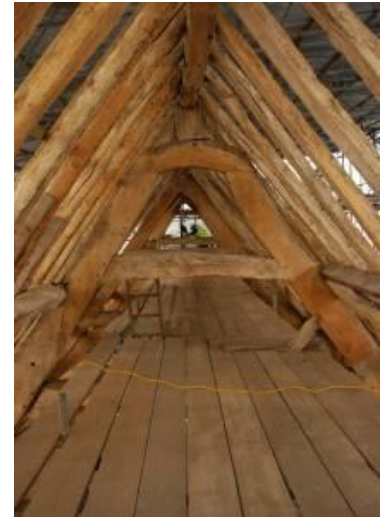
*View of the barn in the process of repair that will prolong the life of this outstanding building.*

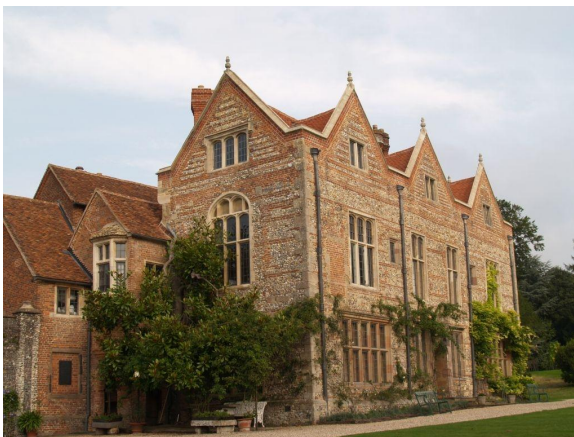
The re-servicing project at Greys Court, a fine Grade I listed Mansion House owned by the National Trust, is finally complete following delays caused by the need to remove extensive asbestos.

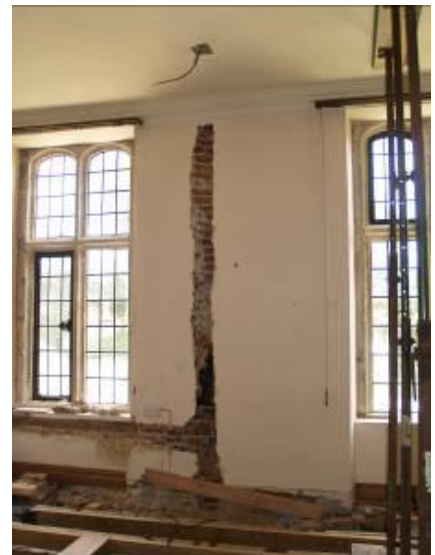
## Recently seen – frost damage at Highmoor

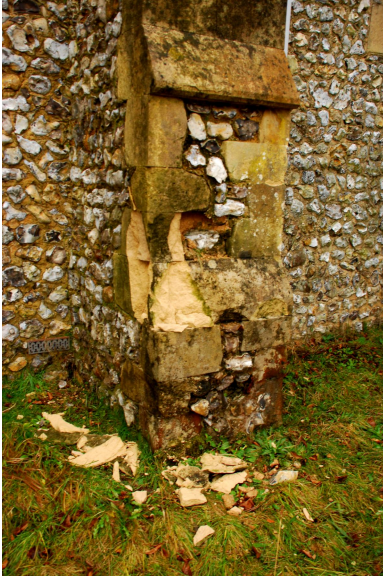
The stone quoin to this buttress has suffered from frost damage during recent cold spells. The unusually cold weather has caused disruption to ongoing projects – with more bad weather predicted next week – can't wait for Spring !

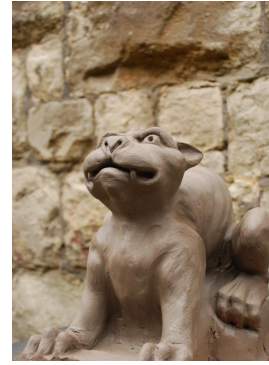
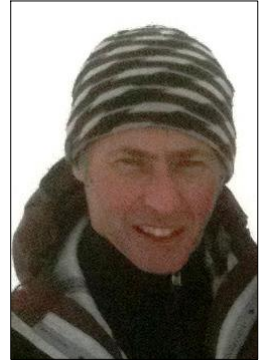
... feel free to insert the caption !

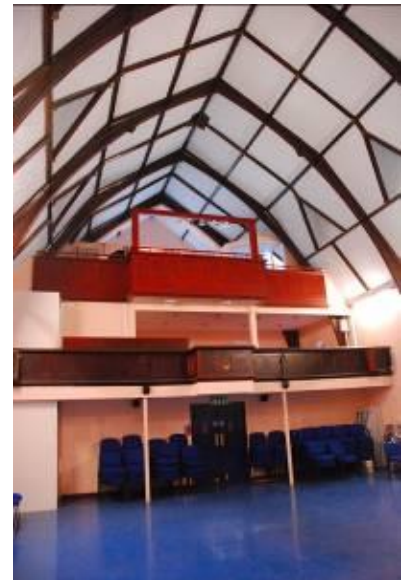
## Donhead book of the month
