## THE NEED FOR ROOFS TO BREATHE

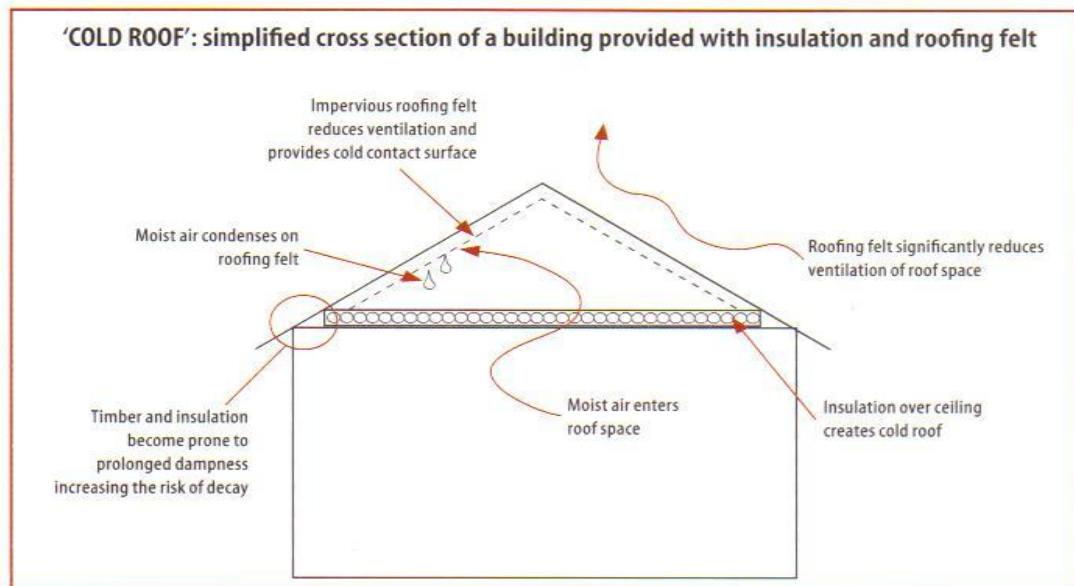
- Any drop in the air temperature provides the atmospheric conditions for the condensation of the moist air to take place.
- The impervious roofing felt provides a high level of resistance to the passage of water vapour and a cold contact surface upon which warm moist air can condense. In these circumstances the rafters in contact with the felt may remain damp most of the time, causing the surface of the rafter to become stained and, in the worst case, rotten – as illustrated below.

As can be seen, the introduction of both a roofing felt and insulation has provided an environment susceptible to condensation, which in turn increases the risk of dampness and associated timber defects.

- The introduction of insulation over a ceiling creates a 'cold roof' (*see diagram*).
- Roofing felt significantly reduces the air movement in the roof space.
- Moist air from the accommodation readily finds its way into the roof space through the ceiling and holes in ill-fitting hatches.
- The amount of evaporation that can take place within the roof is considerably reduced by the introduction of roofing felt.
- Increased amounts of dampness and moist air are now present within the roof space.
- The timbers in the roof space are therefore increasingly subjected to the conditions conducive for active fungal decay and wood boring insect infestation.
